# AN EXAMPLE OF REPAIR/REINFORCEMENT DESIGN FOR AN EXISTING RC-GIRDER BRIDGE UNDER SALT DAMAGE CONDITIONS IN A COLD REGION — A METHOD USING AFRPM WITH PVA SHORT-FIBER-MIXED SHOTCRETE —

Fumio TAGUCHI

Materials Research Team, Civil Engineering Research Institute for Cold Region

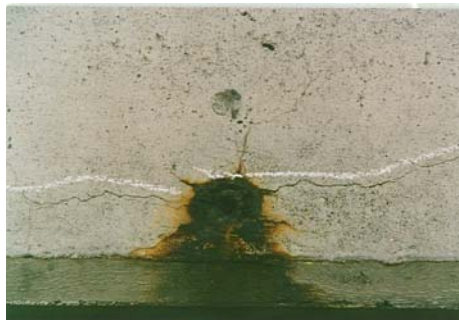
The bridge was put into service in 1973, and a surface coating (epoxy resin-impregnated glass cloth) was applied in 1992, 20 years after its construction, to repair cracking and rust exudation from the main girder (Photo 1). However, cracking continued to progress thereafter, causing damage to the surface coating and partial spalling of the cover concrete by 2002 (ten years after the repair).

**Photo 1:** Damage to the main girder

2) Because the post-treatment of the separator used for the form at the time of construction was inappropriate, corrosion amount increased and

corrosion crack occurred (Photo 1). A photo taken at the time of the initial repair also showed exposure of the rebars due to insufficient covering, as well as corrosion amount increase and corrosion crack at some stirrups.

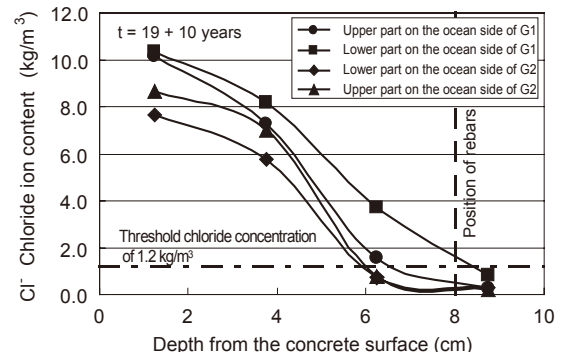
Figure 3 shows the results of the chloride ion content. The curves showing the chloride content are seen to rise at a depth of approximately 4 cm. This was probably because of the progress of rediffusion of the chloride ions included inside, even though the external chloride ion supply was blocked by the coating applied approximately 20 years after construction. The chloride ion contents at the position of rebars were below the threshold chloride ion content for corrosion onset ( $1.2 \text{ kg/m}^3$ ) except in one section.

**Figure 3:** Chloride ion content on the ocean side of the main girder

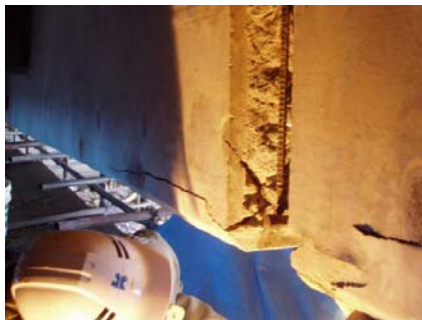
3) Even though chloride ion infiltration was blocked by the repair in 1992 (involving the coating of the concrete surface), the rediffusion of chloride ions remaining inside the concrete and the infiltration of water from the top of the bridge caused the progress of corrosion in the rebars and led to the cracking of the concrete. As cracking also occurred on the coating surface (Photo 2) and accelerated the infiltration of chloride ions, corrosion of the rebars progressed at an accelerated rate.

**Photo 2:** Corrosion induced cracking

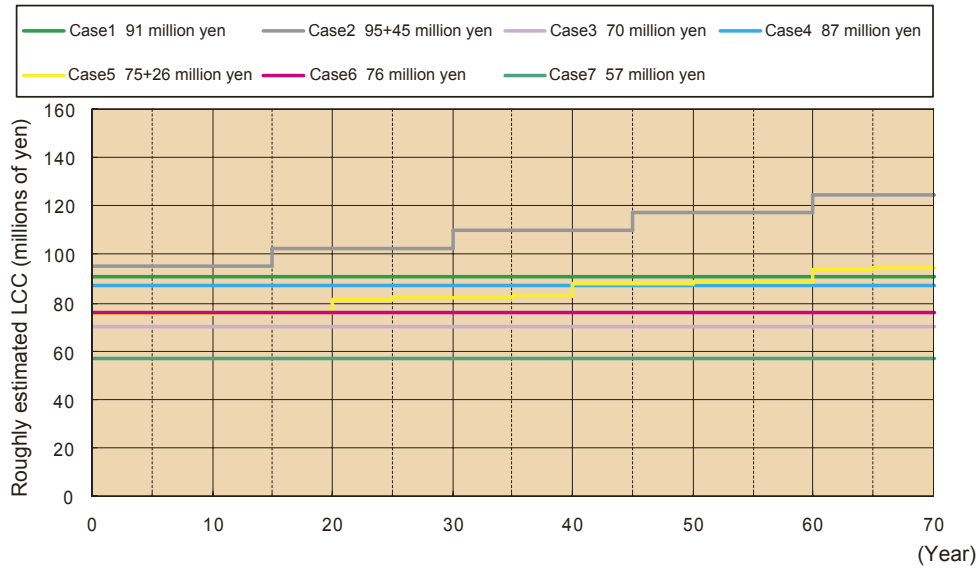
**Figure 4:** Comparison of LCC for Countermeasure

As a result, the use of AFRPm with PVA short-fiber-mixed shotcrete (Case 7 in Fig. 4) was selected as the method with the lowest LCC and a few influences in the traffic.

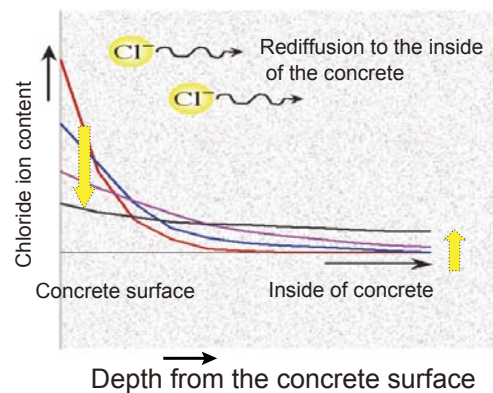
1) Chloride ions content inside rediffuse and gradually become uniform due to the content gradient in the cross section (Fig. 5), if the external chloride ion supply is blocked; the effect of rediffusion must therefore be taken into account when determining the range of cross-section removal (removal depth).

**Figure 5:** Uniformization of chloride ion content by rediffusion

When the removal depth was assumed to be approximately 5 cm on the ocean side, the residual chloride ion content that became uniform as a result of rediffusion was  $0.82 \text{ kg/m}^3$ . The content of the amount predicted to infiltrate over the following 70 years was estimated to be  $0.24 \text{ kg/m}^3$ . By adding these amounts together, the chloride ion content at the position of rebars was estimated to be  $1.1 \text{ kg/m}^3$ , which was lower than the threshold chloride concentration of  $1.2 \text{ kg/m}^3$ . Accordingly, the design removal depth on the ocean side was determined to be 5 cm, while that on the mountain side was determined to be 4 cm using the same method.
