LIFE-CYCLE COST ASSESSMENT FOR FRP STRUCTURES

Itaru Nishizaki

Advanced Materials Research Team, Public Works Research Institute, Japan

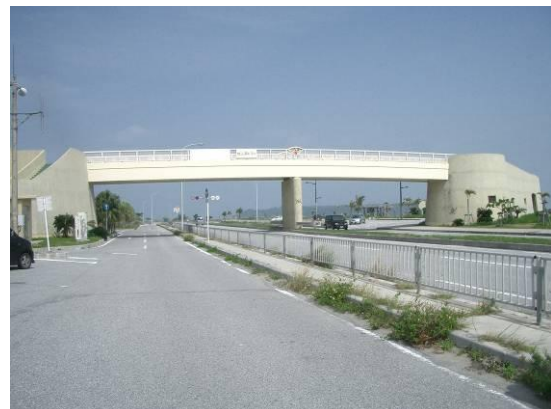
Figure 1: Okinawa Road Park Bridge
(The first all FRP pedestrian bridge in Japan,
Okinawa Prefecture, 2000)

Erected in March 2000, the Okinawa Road Park Bridge (see **Figure 1**) was the first FRP pedestrian bridge built in Japan; prior to this the only FRP

bridges were experimental structures and trial models. The Okinawa Road Park Bridge is a two-span girder bridge with GFRP C-girders. Measuring 37.8 meters in length, it is a public pedestrian bridge spanning an existing vehicle roadway. The original design was for a PC bridge, but lightweight FRP was chosen instead due to concerns about sea salt corrosion from the surrounding seas as well as poor ground conditions. The bridge was heralded as the first genuine FRP trial in Japan which would demonstrate the future potential of this material. For this reason, an LCCA of the FRP bridge compared to conventional PC bridge materials was not performed at the time.

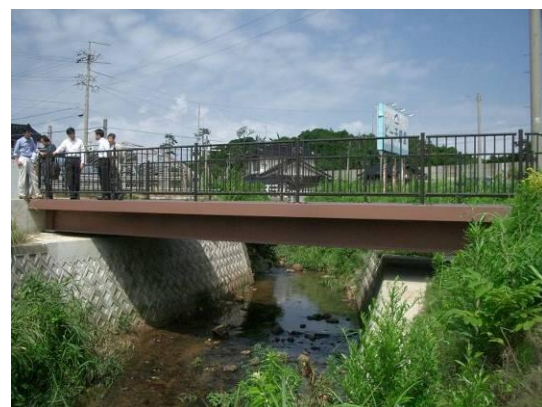
Figure 2: Jitenshodo-13-go bridge (Hakui, Ishikawa Pref., 2008)

After the Okinawa Road Park Bridge in 2000, it was some time before the next FRP bridge appeared in Japan. During this period, much attention was given to the task of trying to reduce initial construction costs based on the Okinawa Road Park Bridge design. Finally in March 2008, a single-span FRP girder bridge named Jitenshodo-13-go bridge (13th bridge of the Bicycle Path) was built on a coastal bicycle path in Hakui, Ishikawa prefecture. The bridge is 11.3 meters long with an effective width of 3.5 meters, and is notable for the use of pultruded FRP with no stiffener (see **Figure 2**).

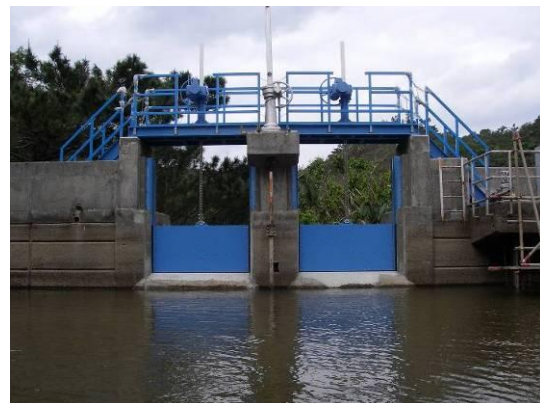
Figure 3: FRP gates at Komagari dam (Ogasawara, 2007)

In 2007, FRP hydraulic gates were installed at Komagari Dam on behalf of Ogasawara-mura (jurisdiction of Tokyo), replacing the previous steel gates (see **Figure 3**). An LCCA was conducted and the results released into the public domain.³⁾ A summary of the results is presented below.

Ogasawara-mura, an island in the Pacific ocean located about 1,000 km from Tokyo, is subject to highly corrosive conditions. The hydraulic gates are used on a water source dam. They replaced a set of steel gates with a width of 2.0 m and a height of 0.96 m, which were severely corroded. The FRP gates were required to be cheaper in terms of initial cost as well as life-cycle cost. Also, due to poor access to the site, the gates were transported by manual labor, so it was important that the gates could be installed relatively easily on site.

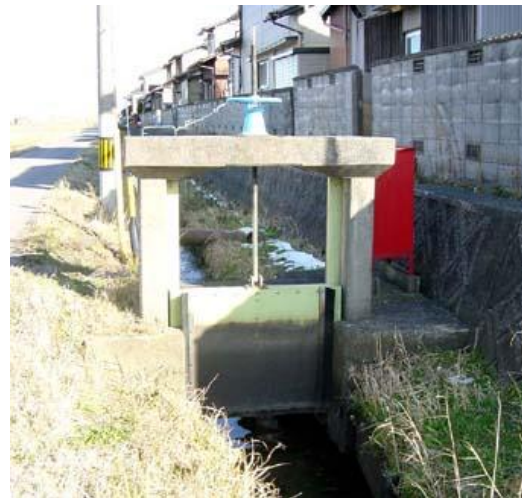
Figure 4: FRP gate in use for 35 years

For the durability study, the author identified and recovered an FRP gate body that had been used as a sluice gate on an agricultural waterway for over 35 years (**Figure 4**). **Table 4** lists key statistics for the recovered FRP gate. Tensile properties were evaluated using the main girder channel and the skin plate of the gate body.
